| | 25/36601574 | Date 21/07/25 |

### Neutral salt fog test according to UNE-EN ISO 9227:2023

**material received** Three (3) panels of approximate dimensions of 30cm x 20cm referenced by the petitioner as "Tecnocoat P-2049" with a thickness of 2mm and with internal number of Applus 32864

**Test requested** Salt spray ageing and visual assessment of defects after 1000 h

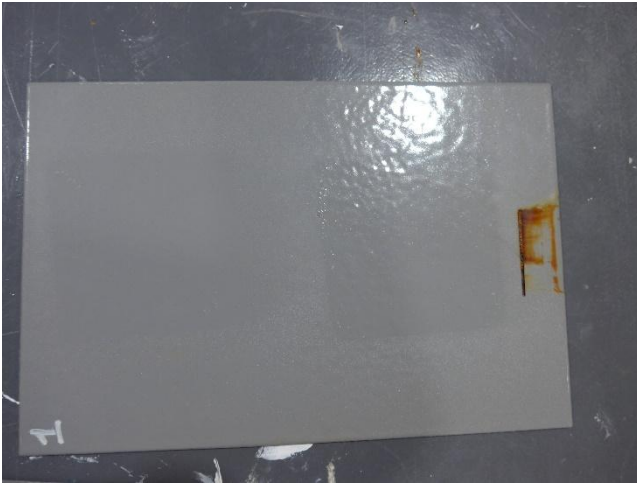
Front side shows 32864-00001

| Test date | Sample | Symptoms of alteration <sup>[2]</sup> | Appearance | Location |
|---|---|---|---|---|
| 0-1000h | <b>32864-00001</b> | No apparent signs of deterioration and/or significant signs of corrosion of the material compared to the receiving state. (ver figura 2 Anexo 2) | | |

| Sample | Results visual assessment | | | |
|---|---|---|---|---|
| 32864-00001 | 0 (S0) | R <sub>i</sub> 0 | 0 (S0) | 0 (S0) |

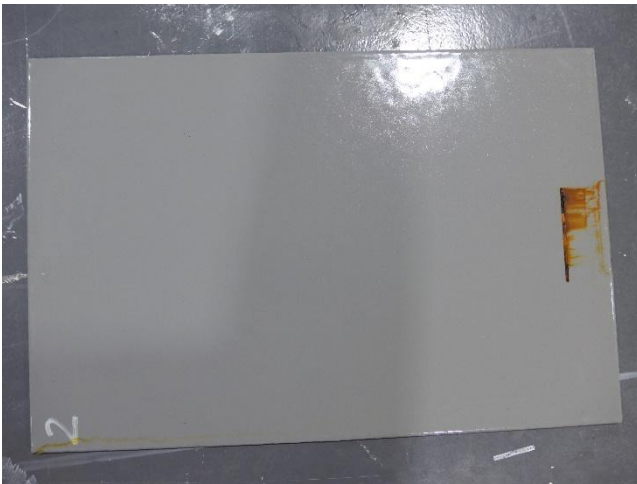
Front side shows 32864-00002

| Test date | Sample | Symptoms of alteration <sup>[2]</sup> | Appearance | Location |
|---|---|---|---|---|
| 0-1000H | <b>32864-00002</b> | No apparent signs of deterioration and/or significant signs of corrosion of the material compared to the receiving state. (ver figura 2 Anexo 2) | | |

| Sample | Results visual assessment | | | |
|---|---|---|---|---|
| 32864-00002 | 0 (S0) | R <sub>i</sub> 0 | 0 (S0) | 0 (S0) |

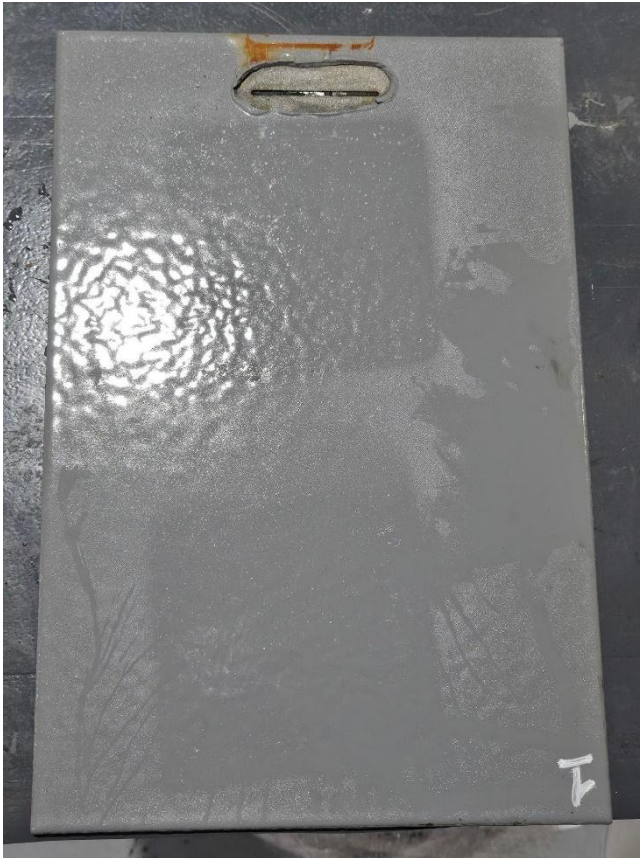
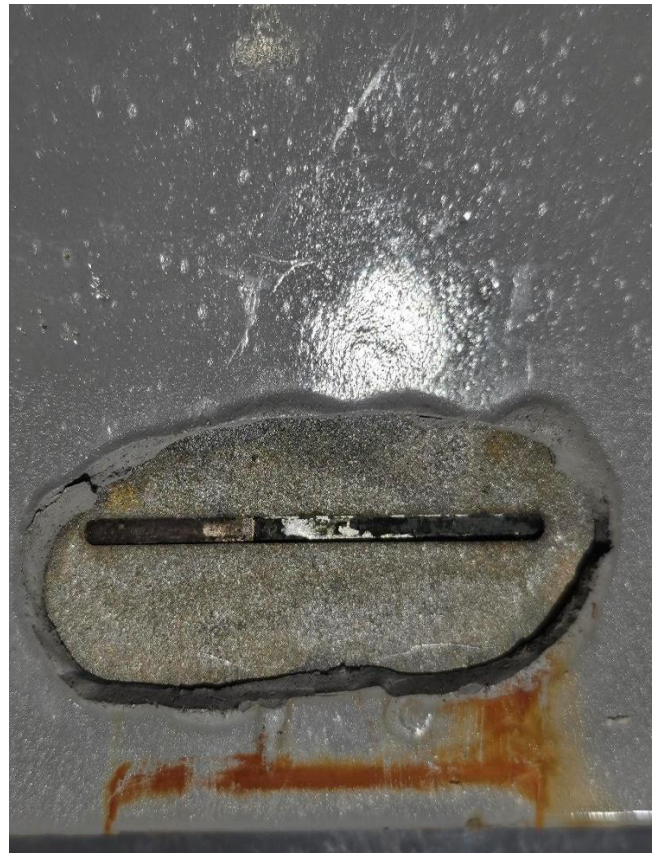
Sample incision 32864-00001

| Sample | Corrosion from the incision (mm) |
|---|---|
| 32864-00001 | 0,32 |

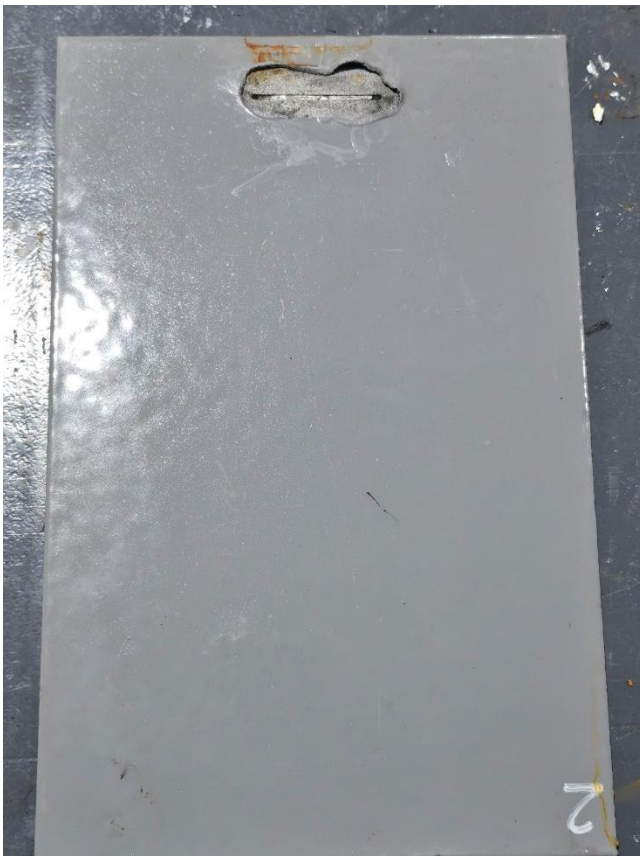
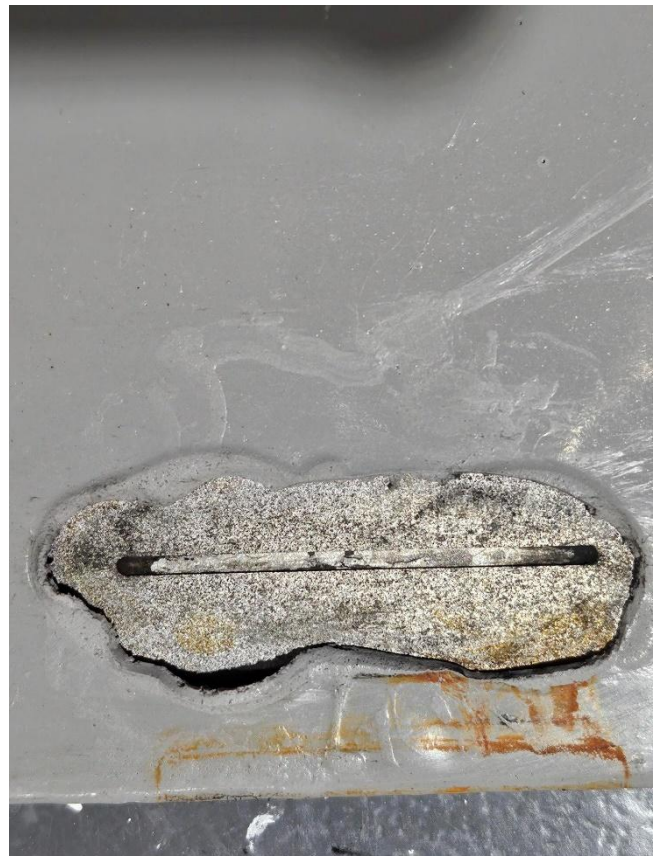
Sample incision 32864-00002

| Sample | Corrosion from the incision (mm) |
|---|---|
| 32864-00002 | 0,14 |
