## Test Report No. 18134B

Primer EP-w-1070 + Tecnocoat P-2049 + Tecnotop 2C

### Nature of the tests

Test methods for external fire exposure to roofs: Test method 2: Method with burning brands and wind. The test has been carried out according to CEN/TS 1187:2012.

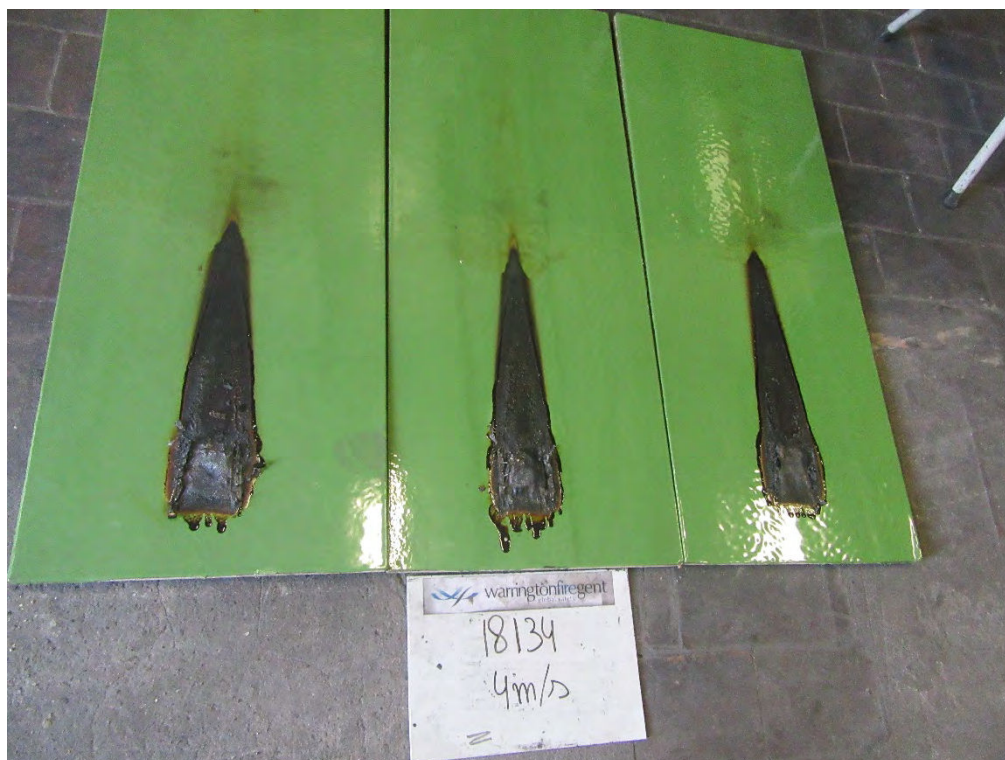
After test at 4 m/s

**Photo of the test specimen before and after the test**

Maximum depth of damage (mm)		2	3	2	2	2	3

Results			
		Mean value	Max. value
2 m/s	Damaged length roof covering (mm)	430	450
	Damaged length substrate (mm)	343	380
4 m/s	Damaged length roof covering (mm)	380	390
	Damaged length substrate (mm)	300	310

Photo of the test specimens before and after the test: Annex 1.
